**RCRA SITE SCREENING INSPECTION REPORT**  
**Enforcement Confidential – Deliberative Process**

SITE NAME: Canton Drop Forge  
EPA ID NUMBER: OHD004465142  
ADDRESS: 4575 Southway Street S.W.  
Canton, Ohio 44706  
DATE OF INSPECTION: July 1, 2011  
EPA INSPECTOR: Michael Beedle

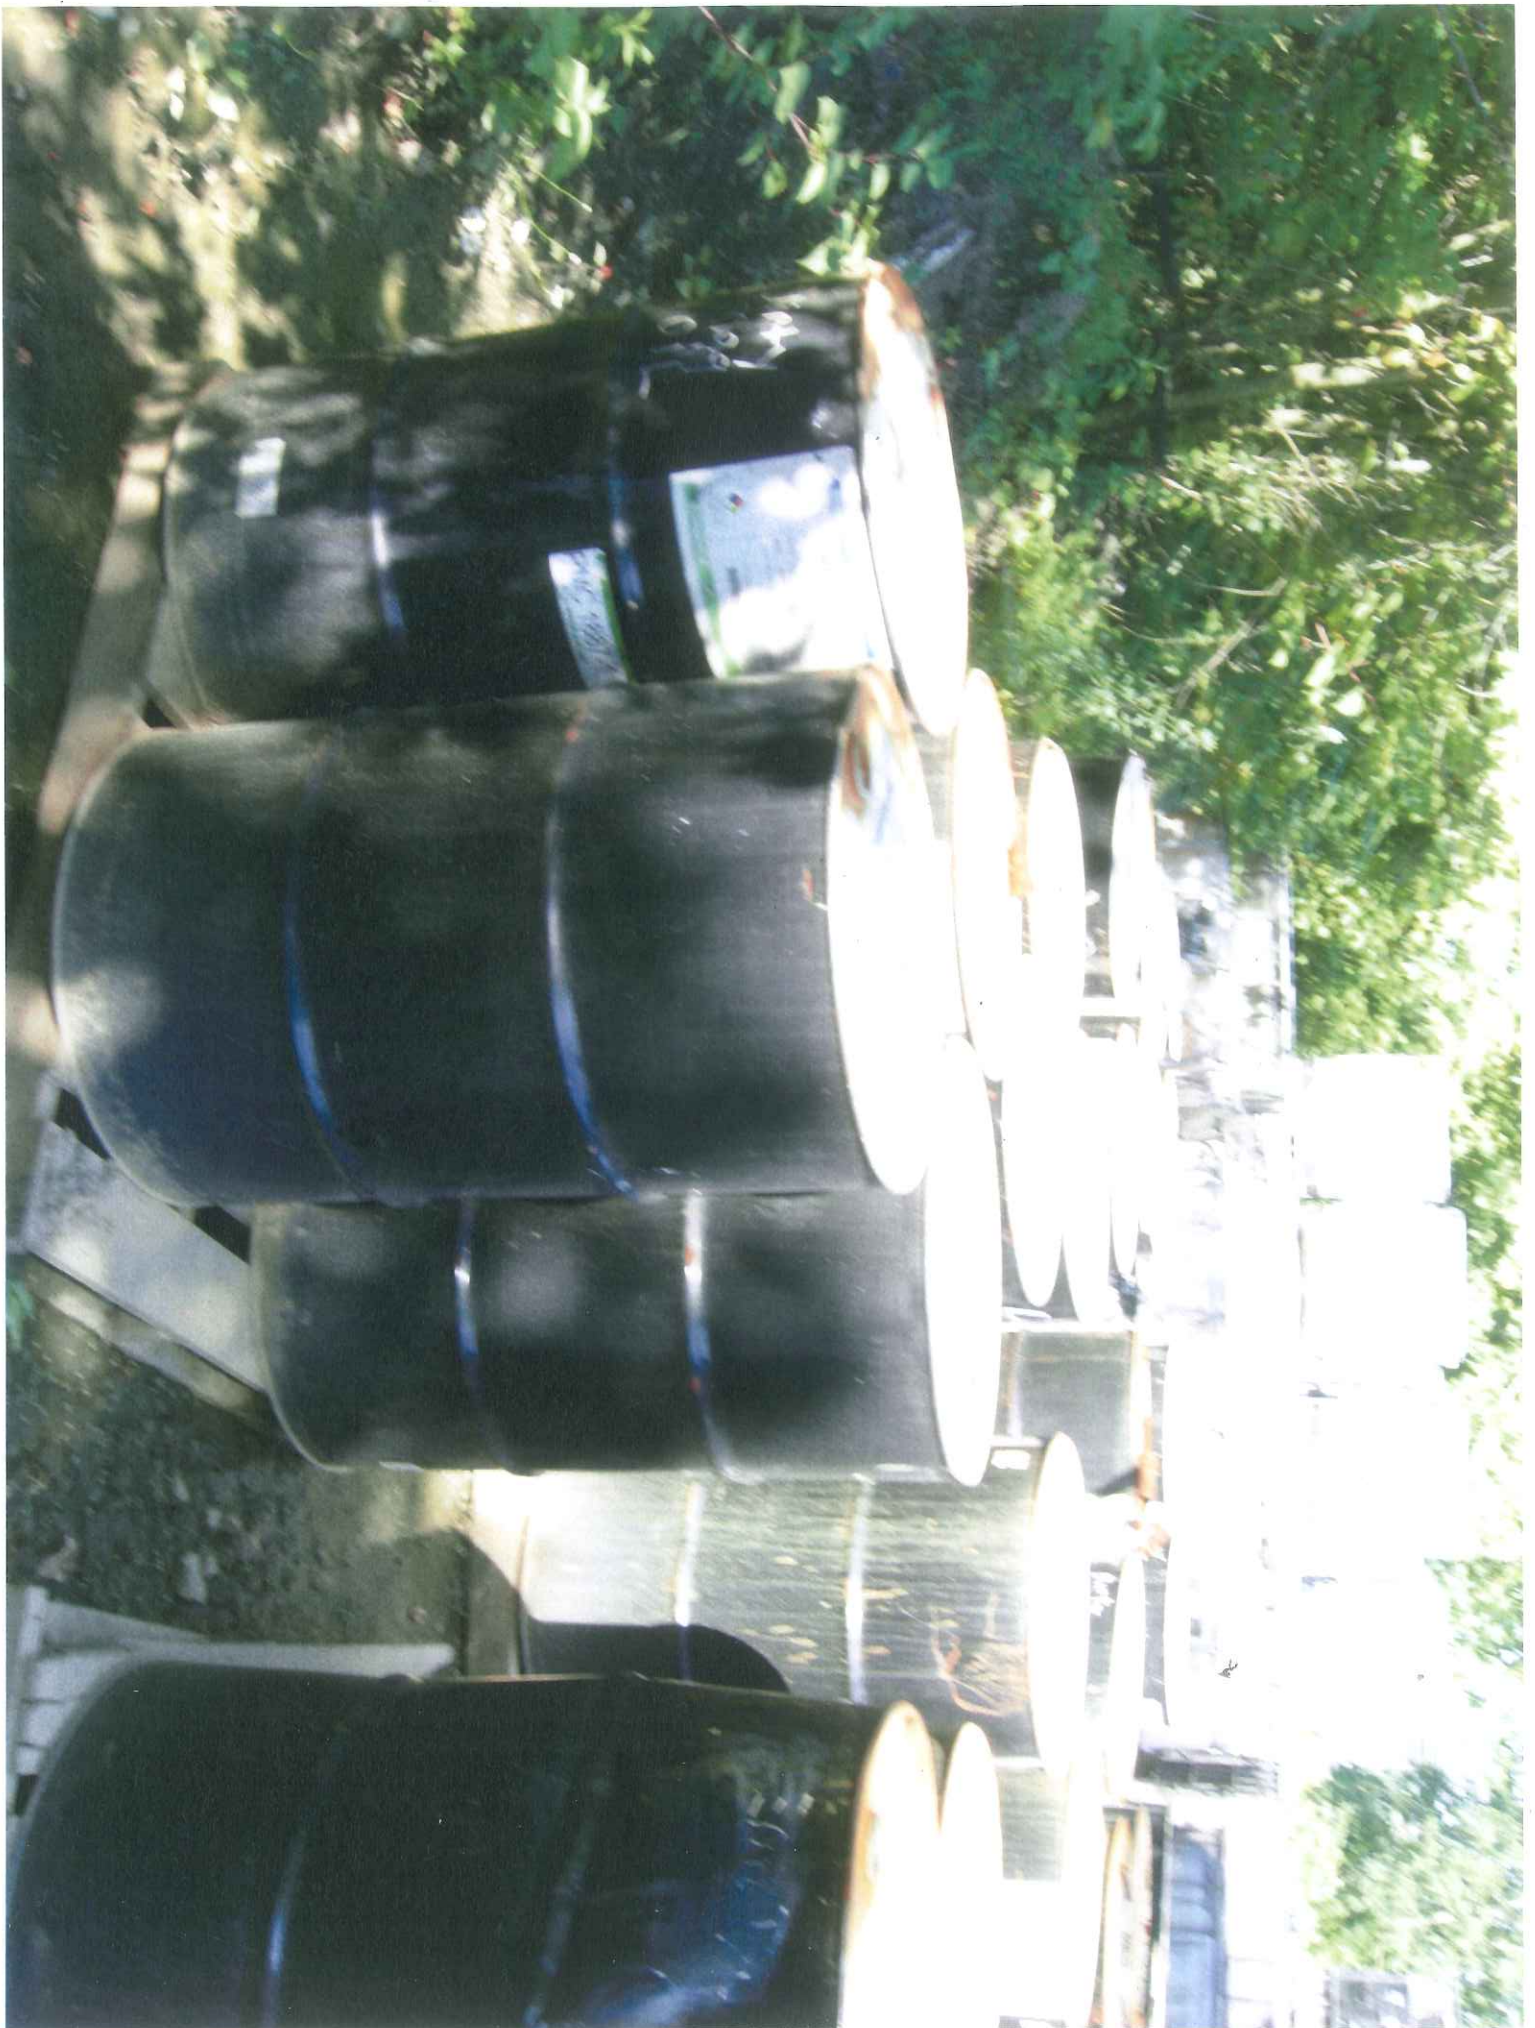
Canton Drop Forge Photo 15, by Mike Beedle ,2011/07/01 07:43:12

| Photo | Description |
|---|--|
| 15 | Black drums same as Photograph 37. Totes seem in the background of this photograph were empty and not the same as photographs 11-12. |

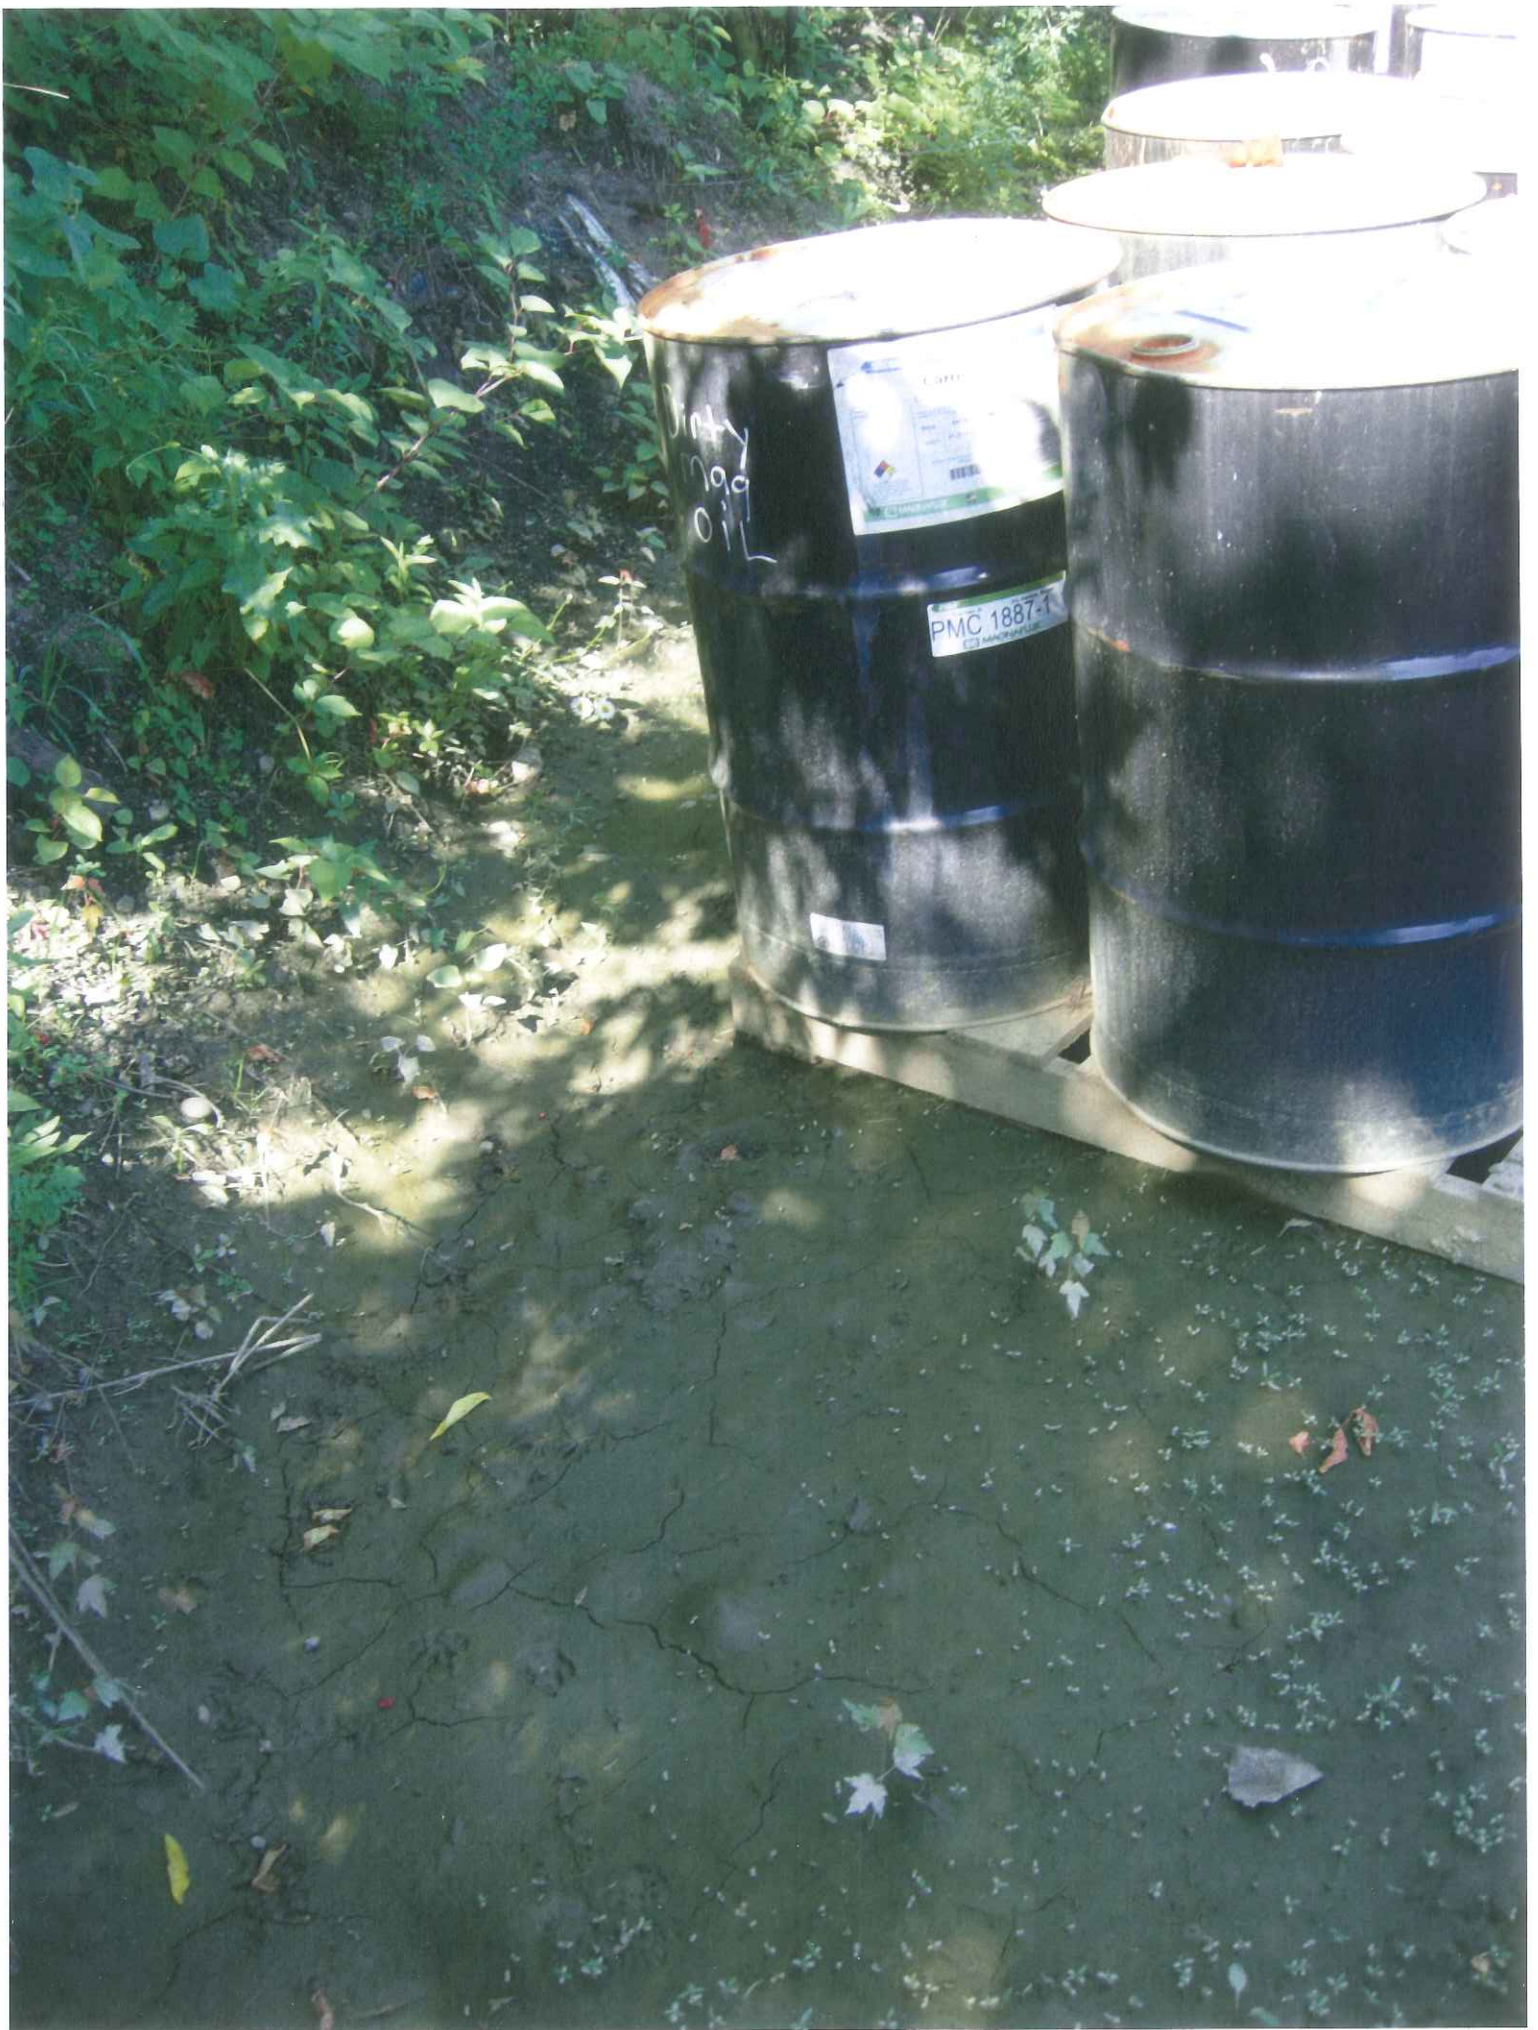
Canton Drop Forge Photo 16, by Mike Beedle ,2011/07/01 07:43:16

| Photo | Description |
|---|--|
| 16 | Raccoon tracks near the black drums on the Southeast side of Pond 2. |

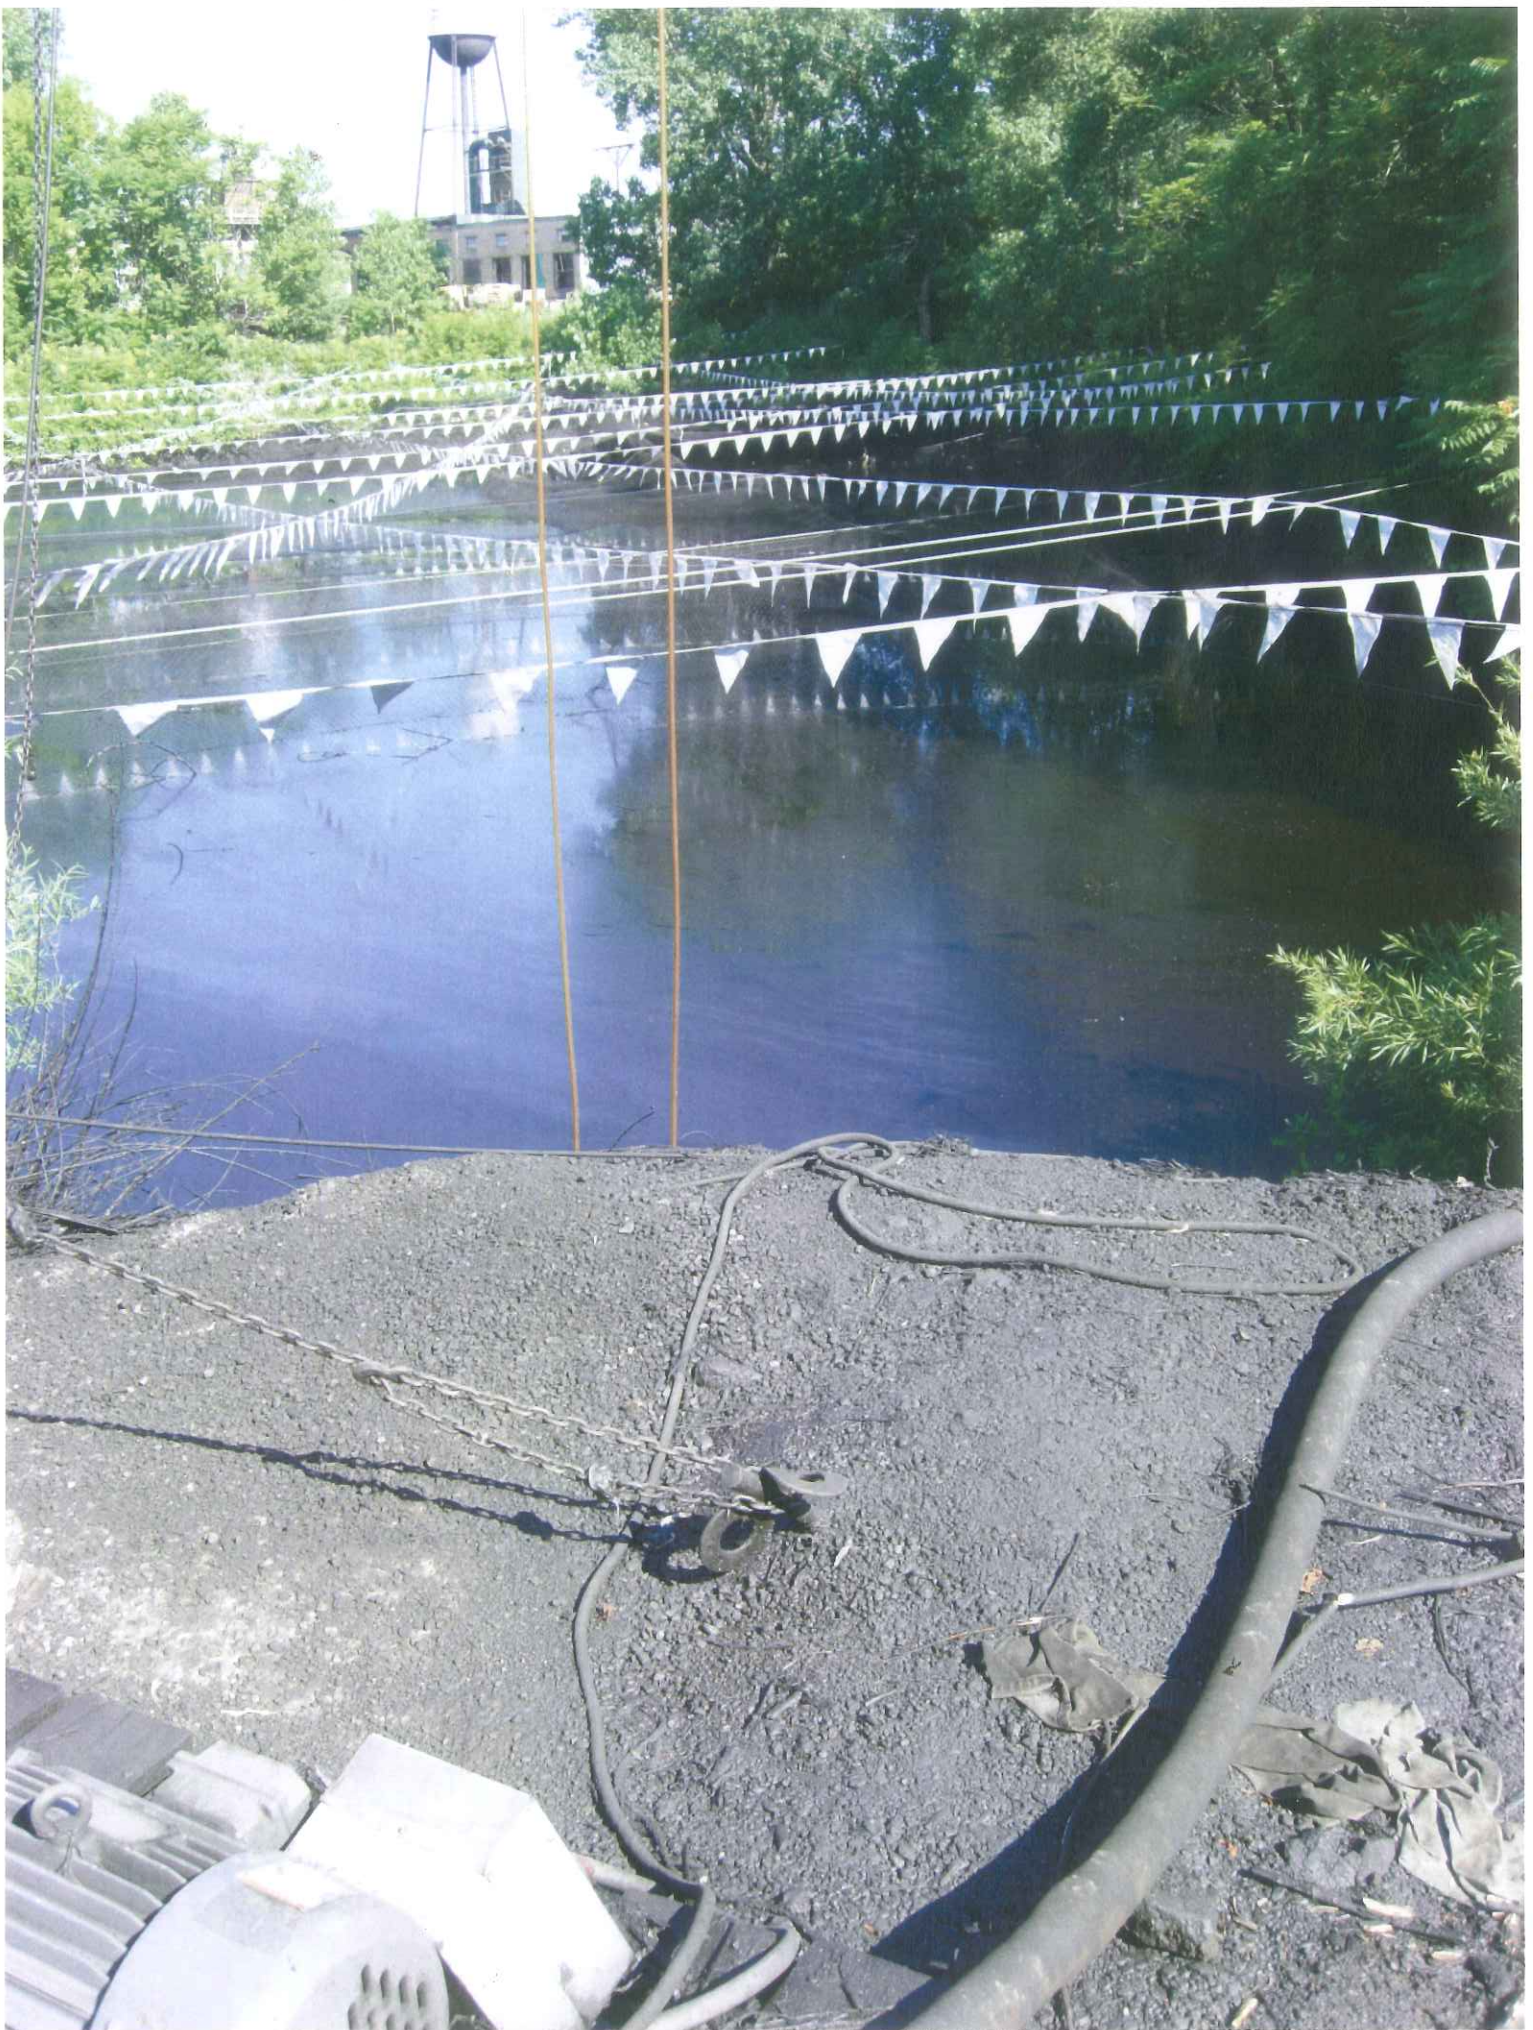
Canton Drop Forge Photo 17, by Mike Beedle, 2011/07/01 07:45:44

There was a skimmer on the southeast corner of Pond 2. The skimmed oil was placed into a tank. The oil is then placed into containers or totes for shipment offsite. Photographs 17, 19, and 23-26 show the skimmer and associated equipment. Photographs 17-18 show a pump and hose used to remove used oil from Pond 2. Photographs 20-22 are of the north east bank of Pond 2. This bank had heavy oil staining and the pond was not fully netted. Photographs 24 and 25 are of tanks

| Photo | Description |
|---|--|
| 17 | Pond 2 facing northwest from the southeast corner. Rope skimmer not operating at the time of the inspection. Pump and hose. Hose into the pond. |

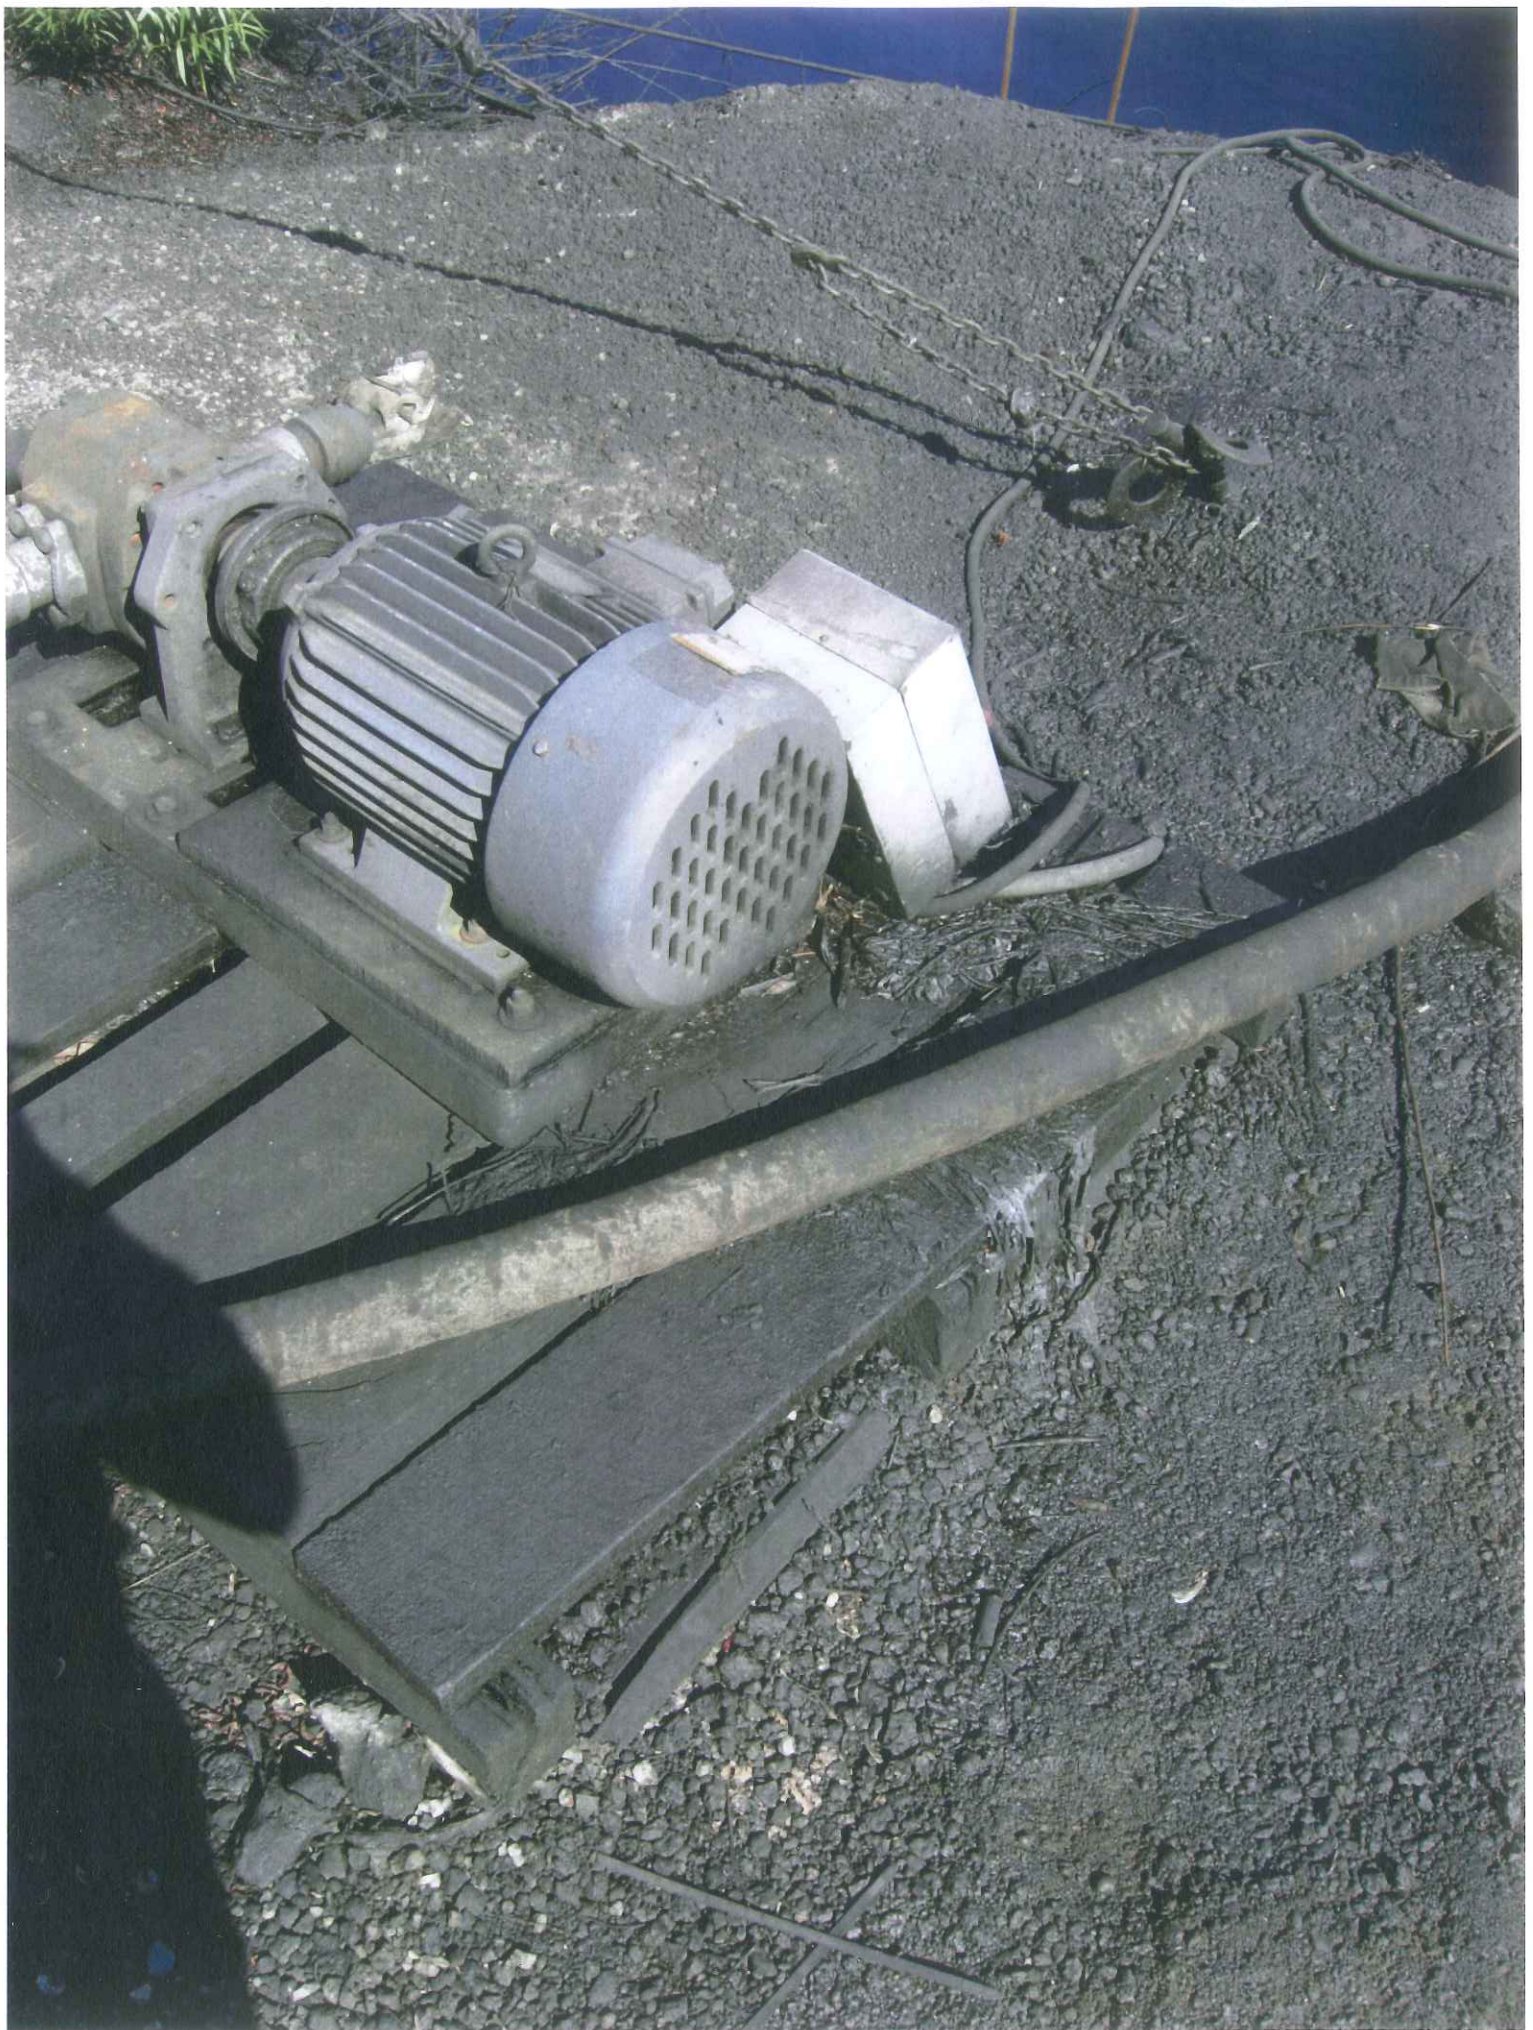
Canton Drop Forge Photo 18, by Mike Beedle ,2011/07/01 07:45:49

| Photo | Description |
|---|--|
| 18 | Pump and hose in southeast corner of Pond 2. Oil stained area. |

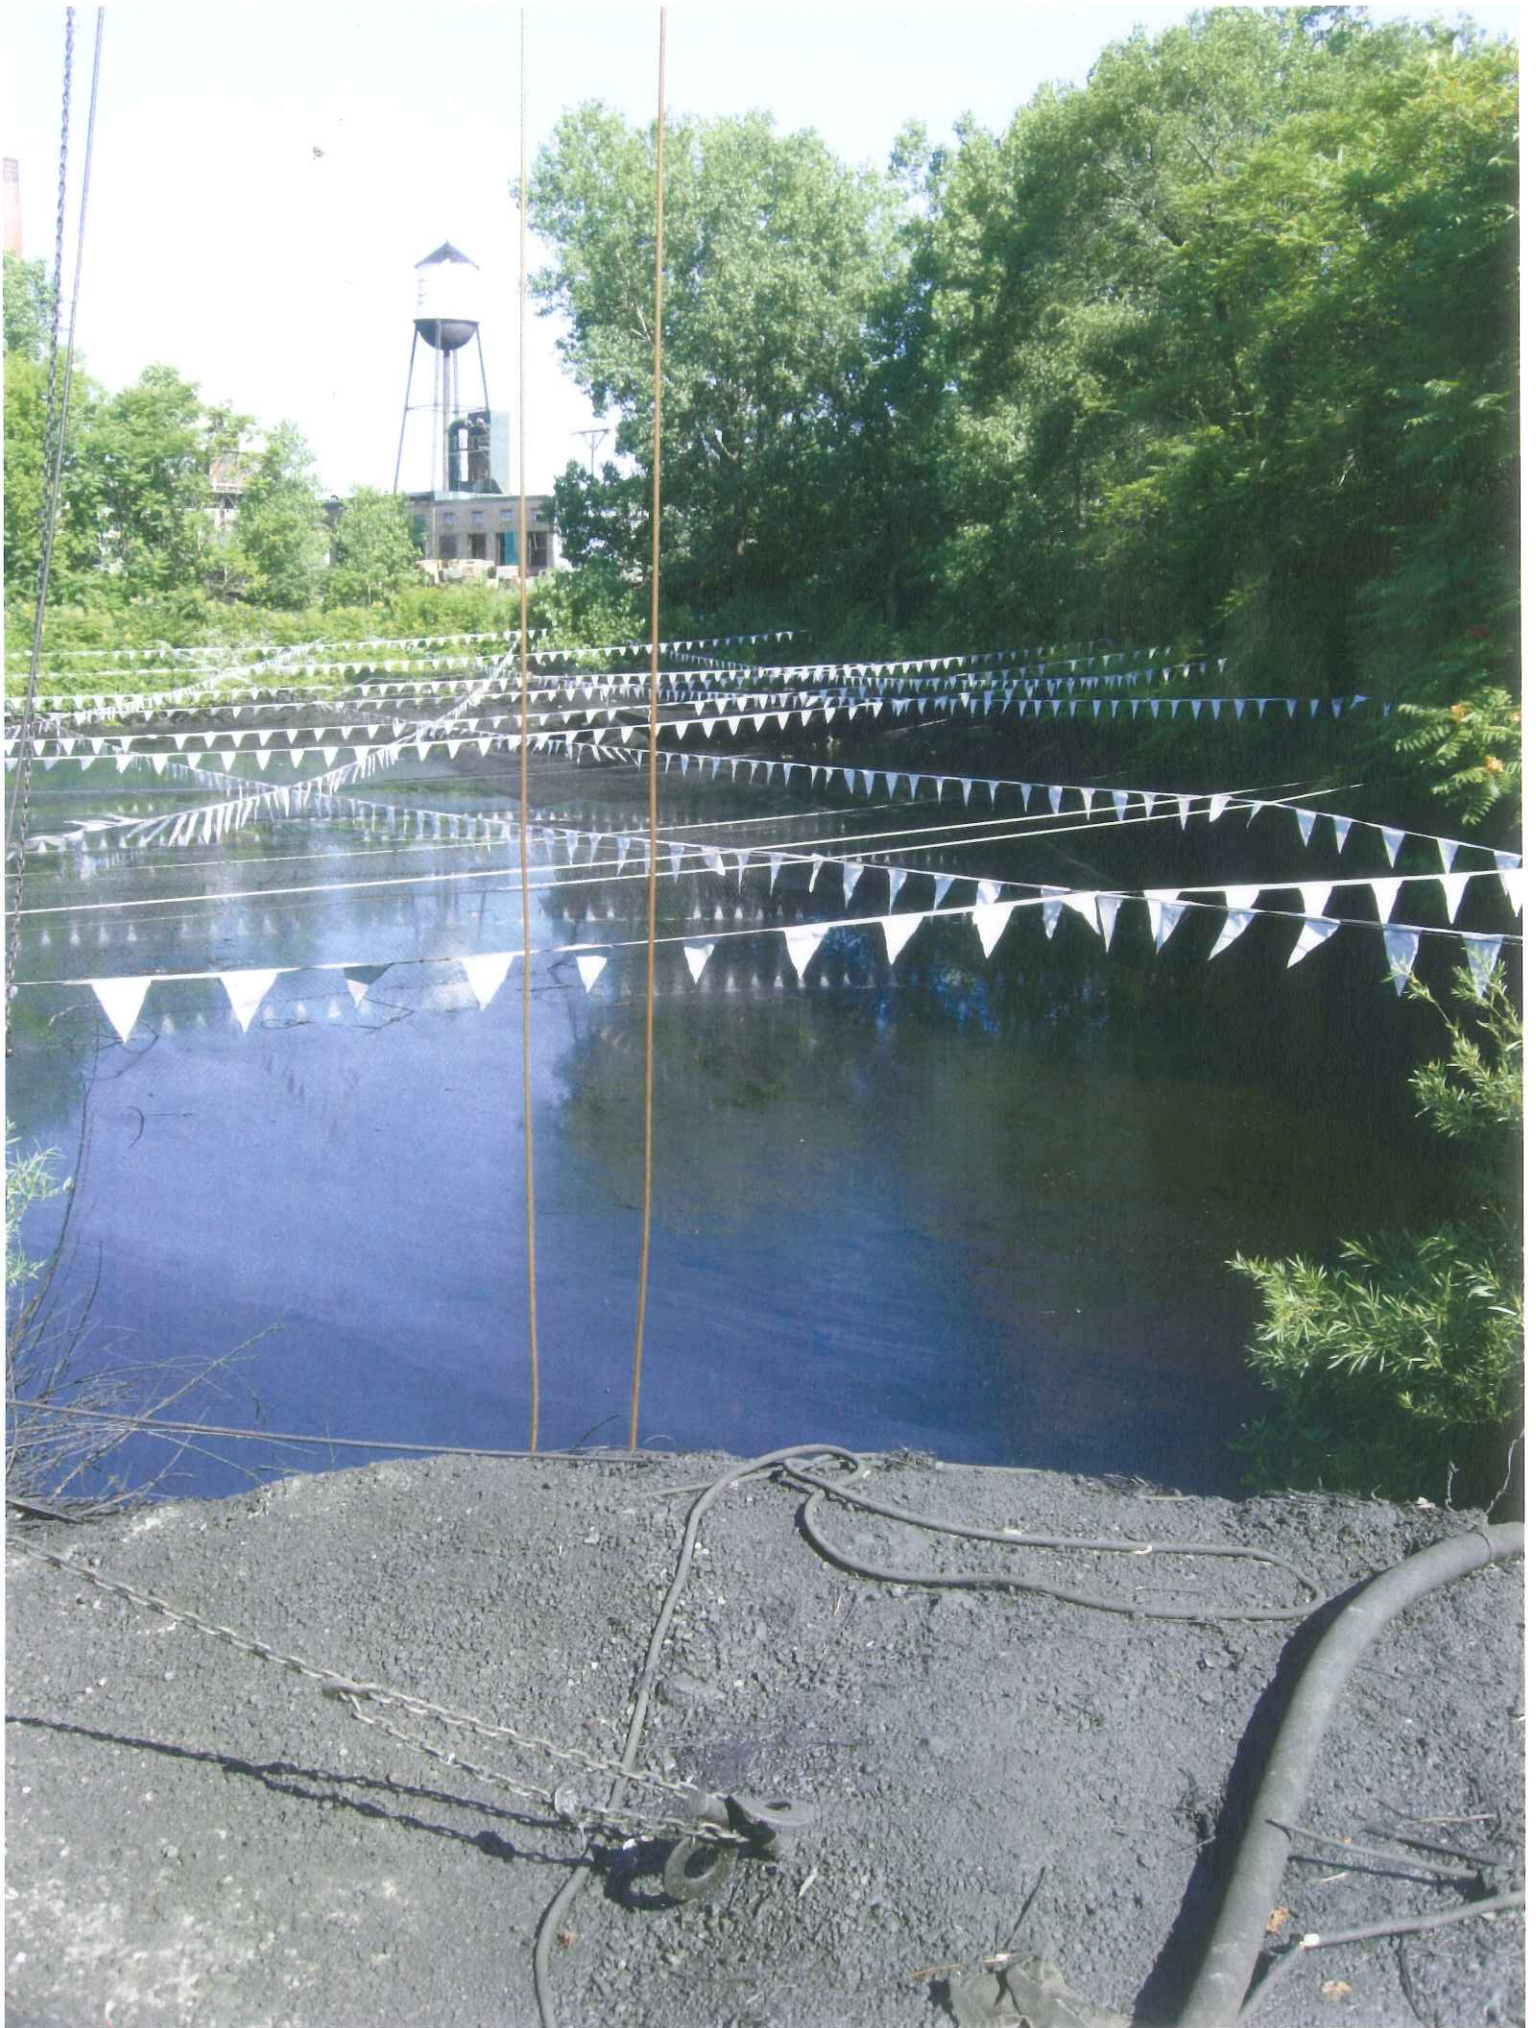
Canton Drop Forge Photo 19, by Mike Beedle ,2011/07/01 07:45:54

| Photo | Description |
|---|--|
| 19 | Rope skimmer at southeast corner of Pond 2. |

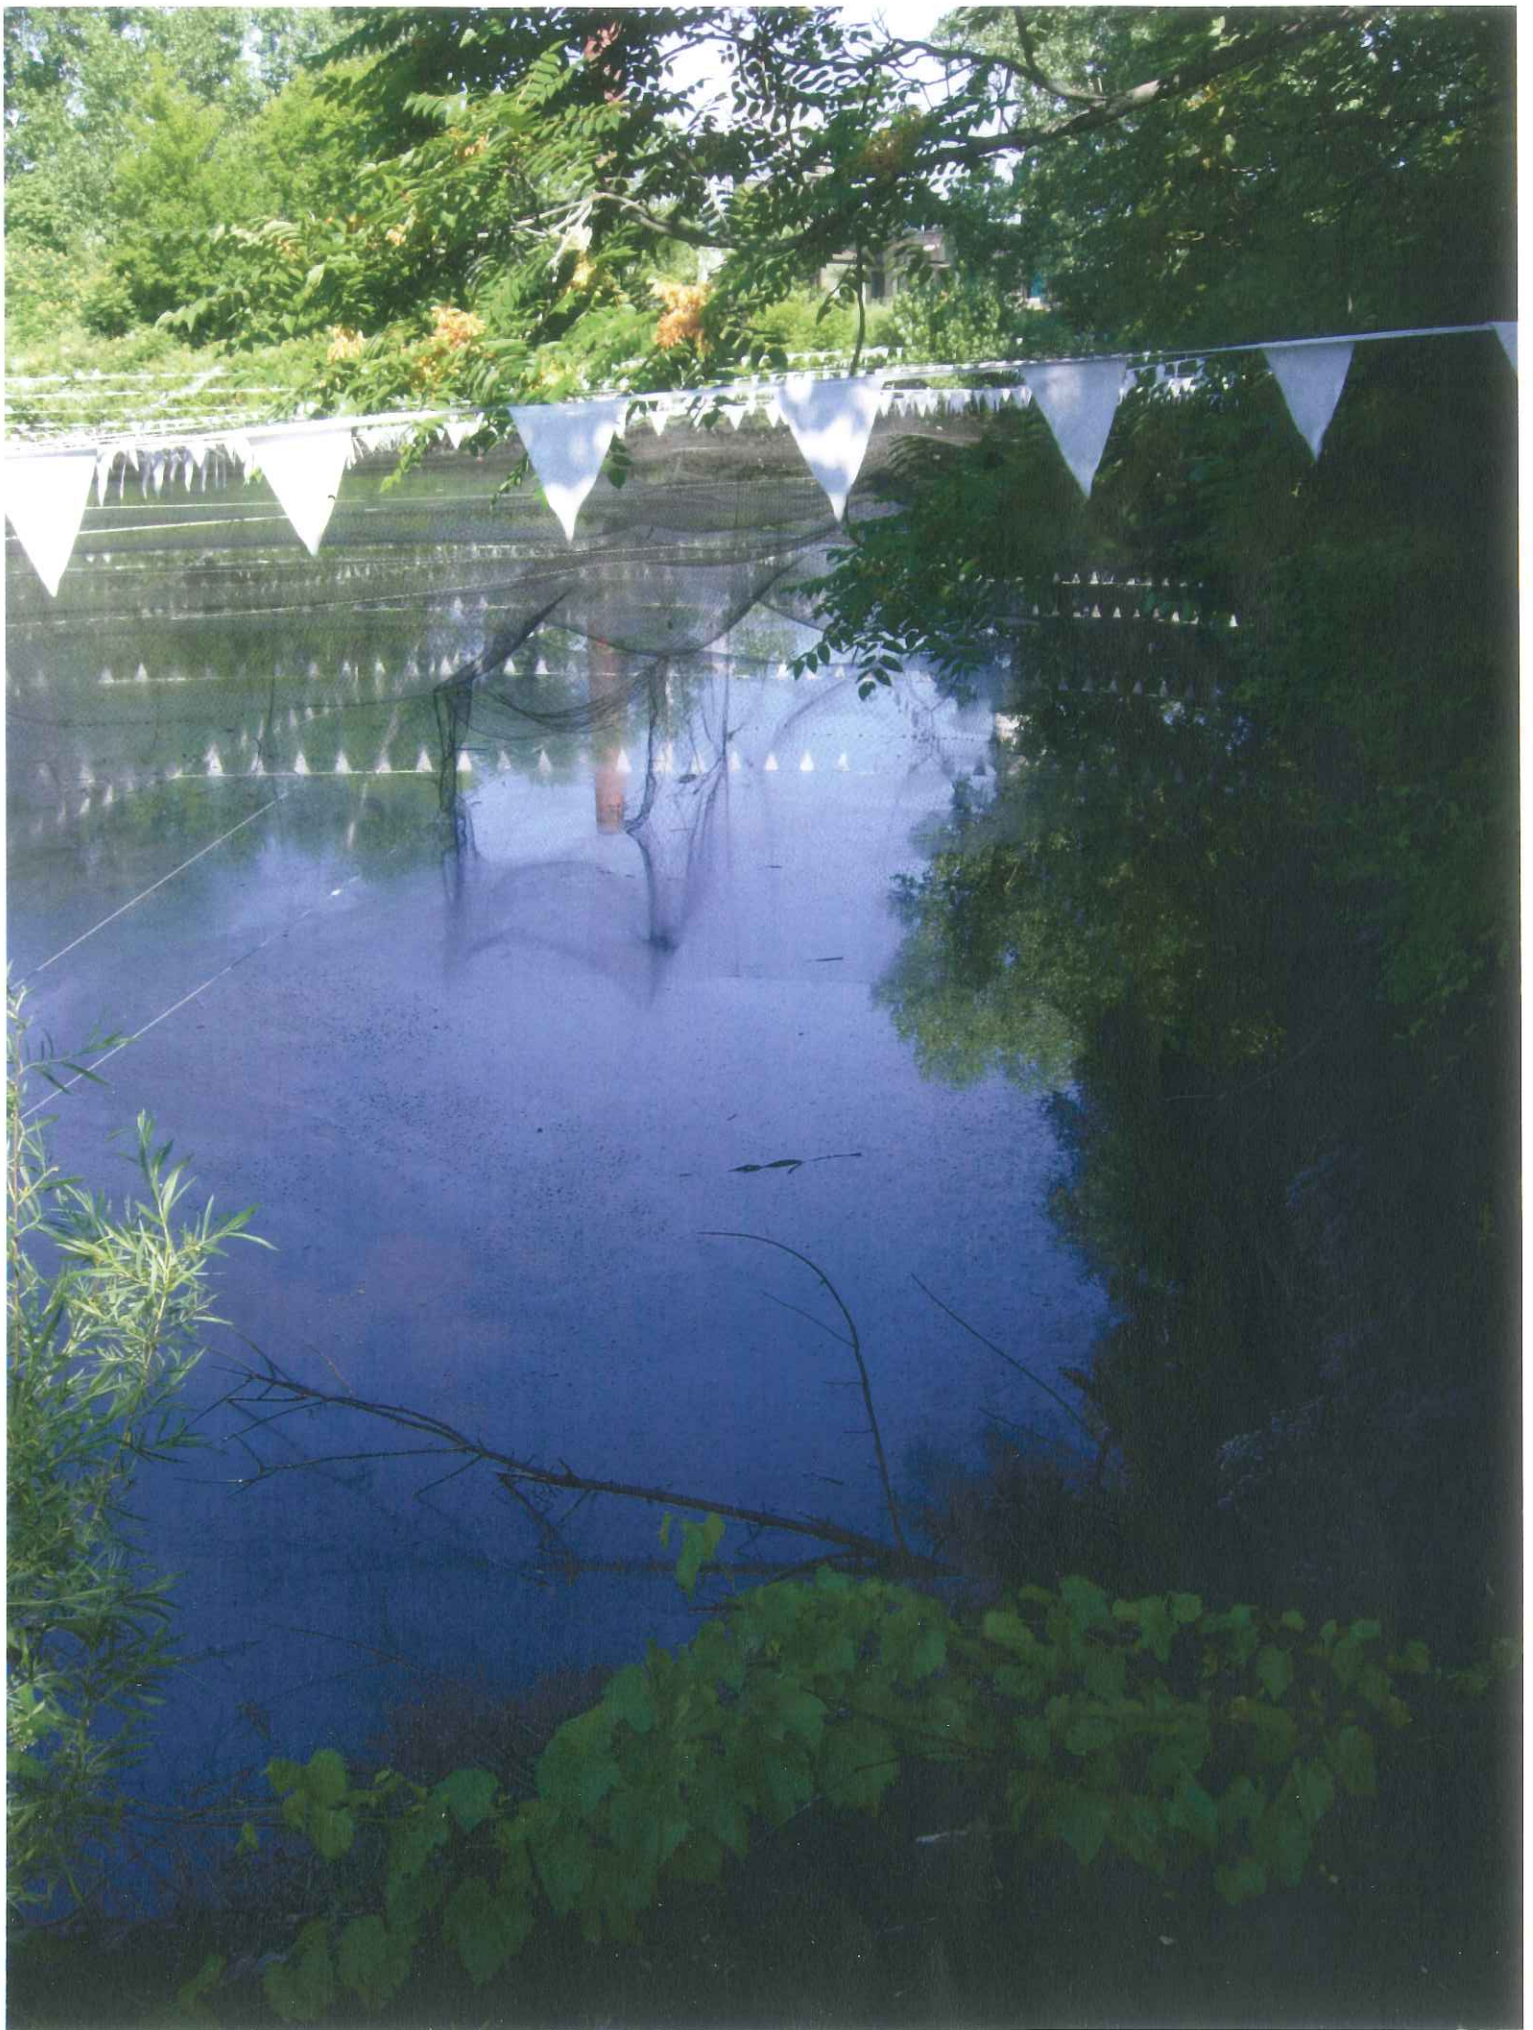
Canton Drop Forge Photo 20, by Mike Beedle ,2011/07/01 07:46:29

| Photo | Description |
|---|--|
| 20 | Pond 2 northeast corner. Net is not covering the whole pond. |

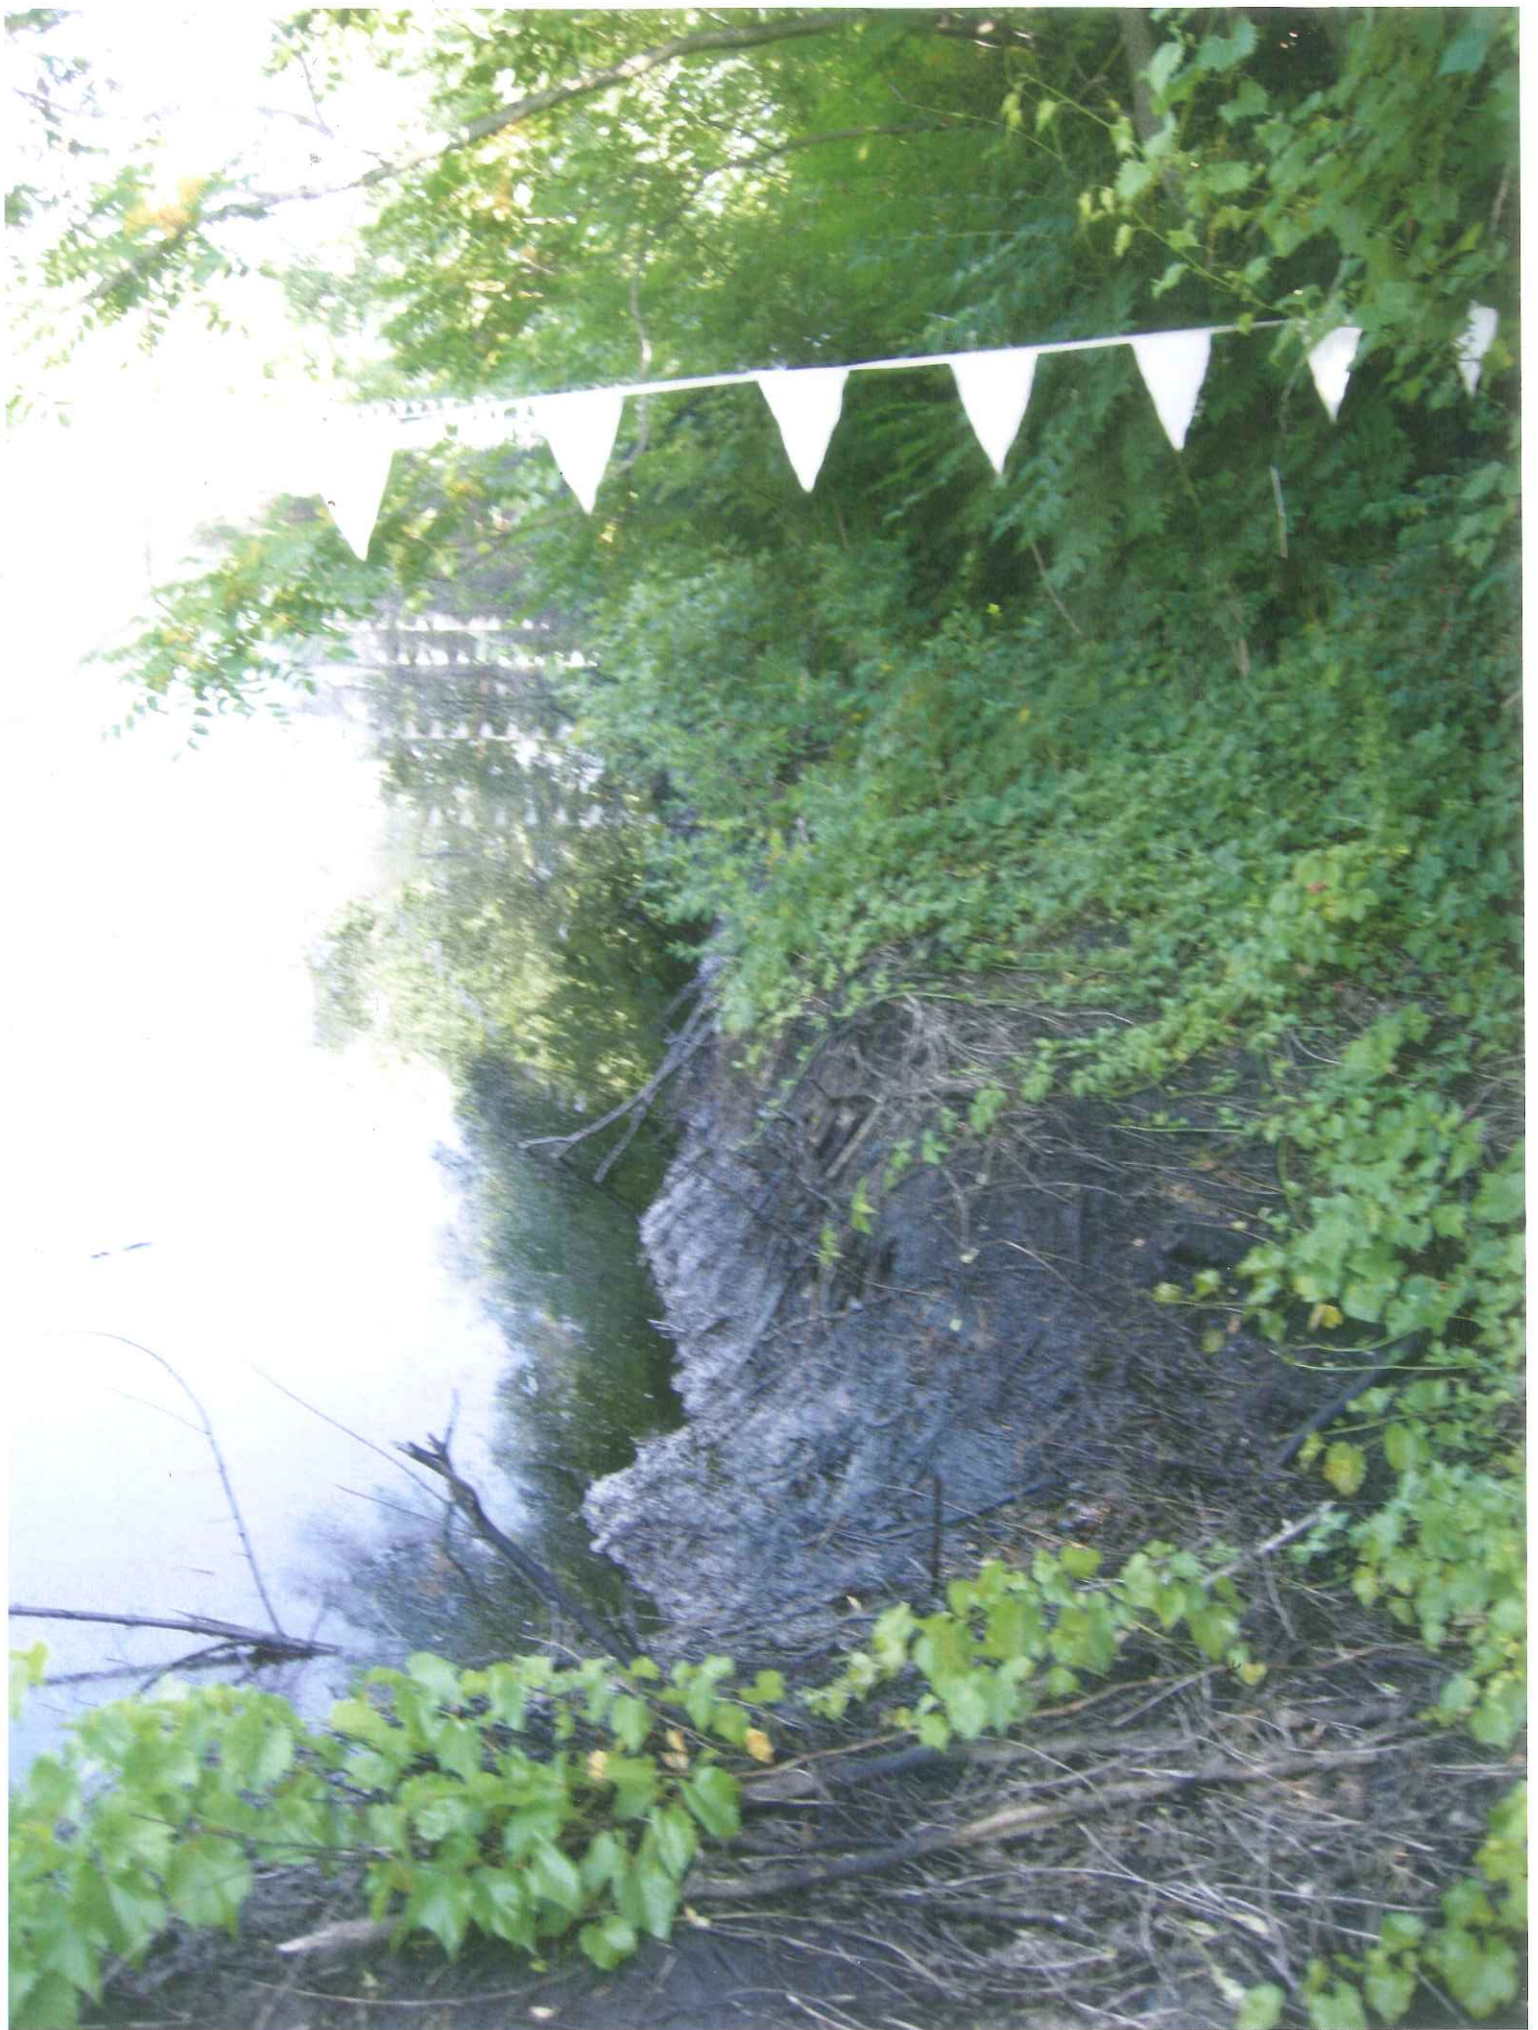
Canton Drop Forge Photo 21, by Mike Beedle ,2011/07/01 07:46:36

| Photo | Description |
|---|--|
| 21 | North bank of Pond 2. Heavily oiled stained. Dead vegetation. |
